TECHNICAL BULLETIN

Radianz® Crack Prevention Case Study

RZ-312-2016

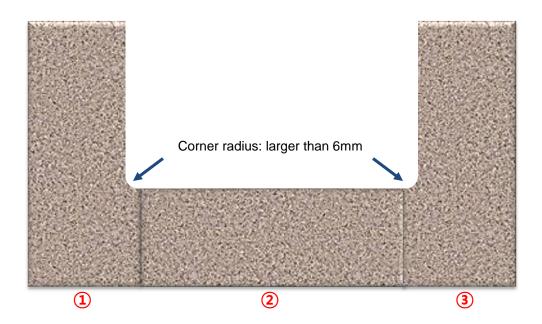
FABRICATION 2: L-shape & U-shape design

Crack Solution

- Make the L & U-Shape with 2 & 3 pieces.
- round the corner larger than 6mm radius.

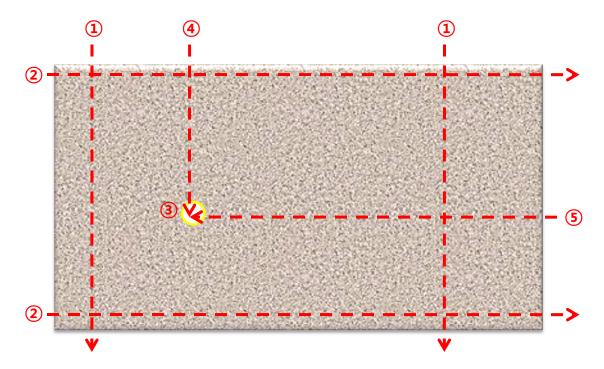
FABRICATION 3: L-shape

- Step 1, 2: Trim the slab. Make smallest size.
- Step 3 : Drill the hole.
- Step 4, 5: Cut the L-shape from out side toward the relief hole.
 - * Cut the shortest first, start from outside

- Slow down the speed for step 4 and step 5. (speed recommendation: < 1m/min)

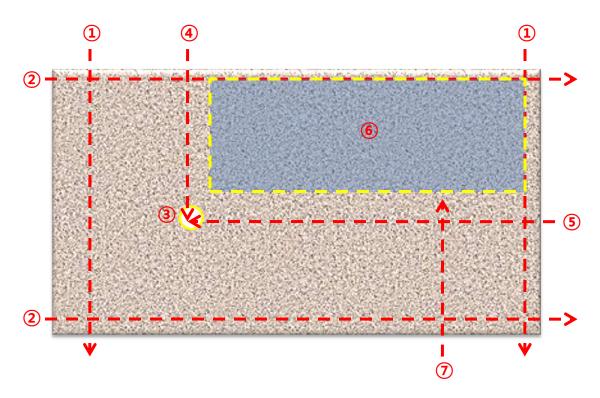
FABRICATION 4: L-shape + more piece (ect. Island)

- Step 1, 2: Trim the slab. Make smallest size.
- Step 3 : Drill the hole.
- Step 4, 5: Cut the L-shape from out side toward the relief hole.
- Step 6 : Separate Island piece from L-shape piece.
- Step 7 : Trim the L-shape size
 - * Cut the shortest first, start from outside

- Slow down the speed for step 4 and step 5. (speed recommendation: < 1m/min)

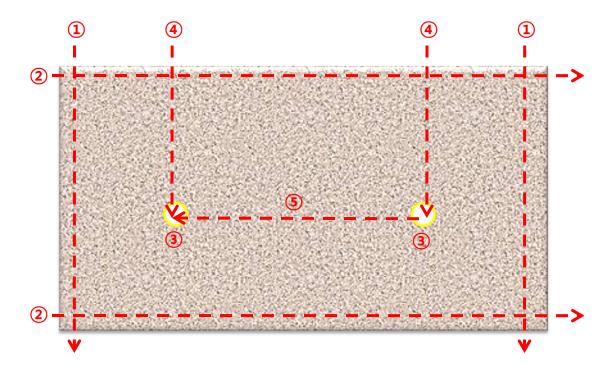
FABRICATION 5 : U-shape

- Step 1, 2: Trim the slab. Make smallest size.
- Step 3 : Drill the hole.
- Step 4, 5: Cut the U-shape from out side toward the relief hole.
 - * Cut the shortest first, step 5 is the latest cut

- Rather than design one piece of U-shape, separate into three piece
- Slow down the speed for step 4 and step 5. (speed recommendation: < 1m/min)

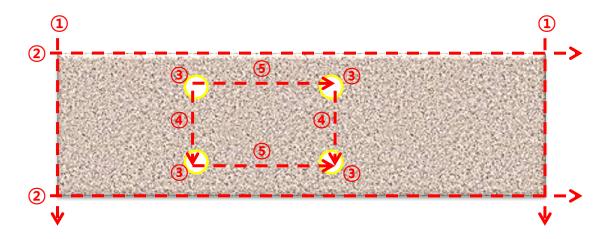
FABRICATION 6: Cut-out

- Step 1, 2: Trim the slab. Make smallest size.
- Step 3 : Drill the hole.
- Step 4, 5: Strait cut (diamond disk grinder can be used with plenty of water)

- Bigger size top is more risky than smaller one. Before cut-out, trim first and make smallest size.
- Slow down the cutting speed for a case of big island cut-out.

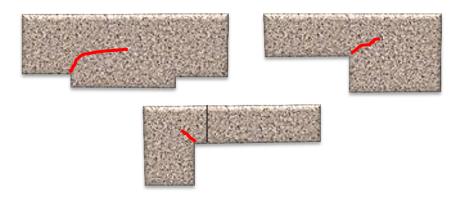
CRACK CASE 2: Square inside corner

After fabrication or installation

- Do not comply with fabrication manual.
- Straight cut Without corner drilling.
- Radius inside corners to a minimum of 6mm will reduce corner stresses.

- Any inside corner must have 6mm minimum radius.

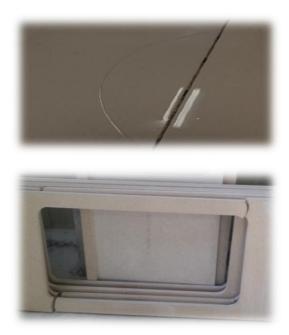
CRACK CASE 8: Brittleness by low temperature

· During fabrication

- Increased brittleness cause by low temperature.

- Decelerate the cutting speed 20%~30%.
- If the stored at outside or low temperature, move the slab to building inside or warm place at least 24 hours at 15~20 °C.
